**Subject: Third Quarter 2015 Progress Report for EVRAZ Oregon Steel Facility in
Portland, Oregon WPMVC-NWR-00-10**

OERS No. 2015-1487
7-7-2015 Release of
Hydraulic Oil
General Location

EVRAZ Portland - Double Joiner
OERS 2015-2056 - hydraulic oil spill - September 7, 2015

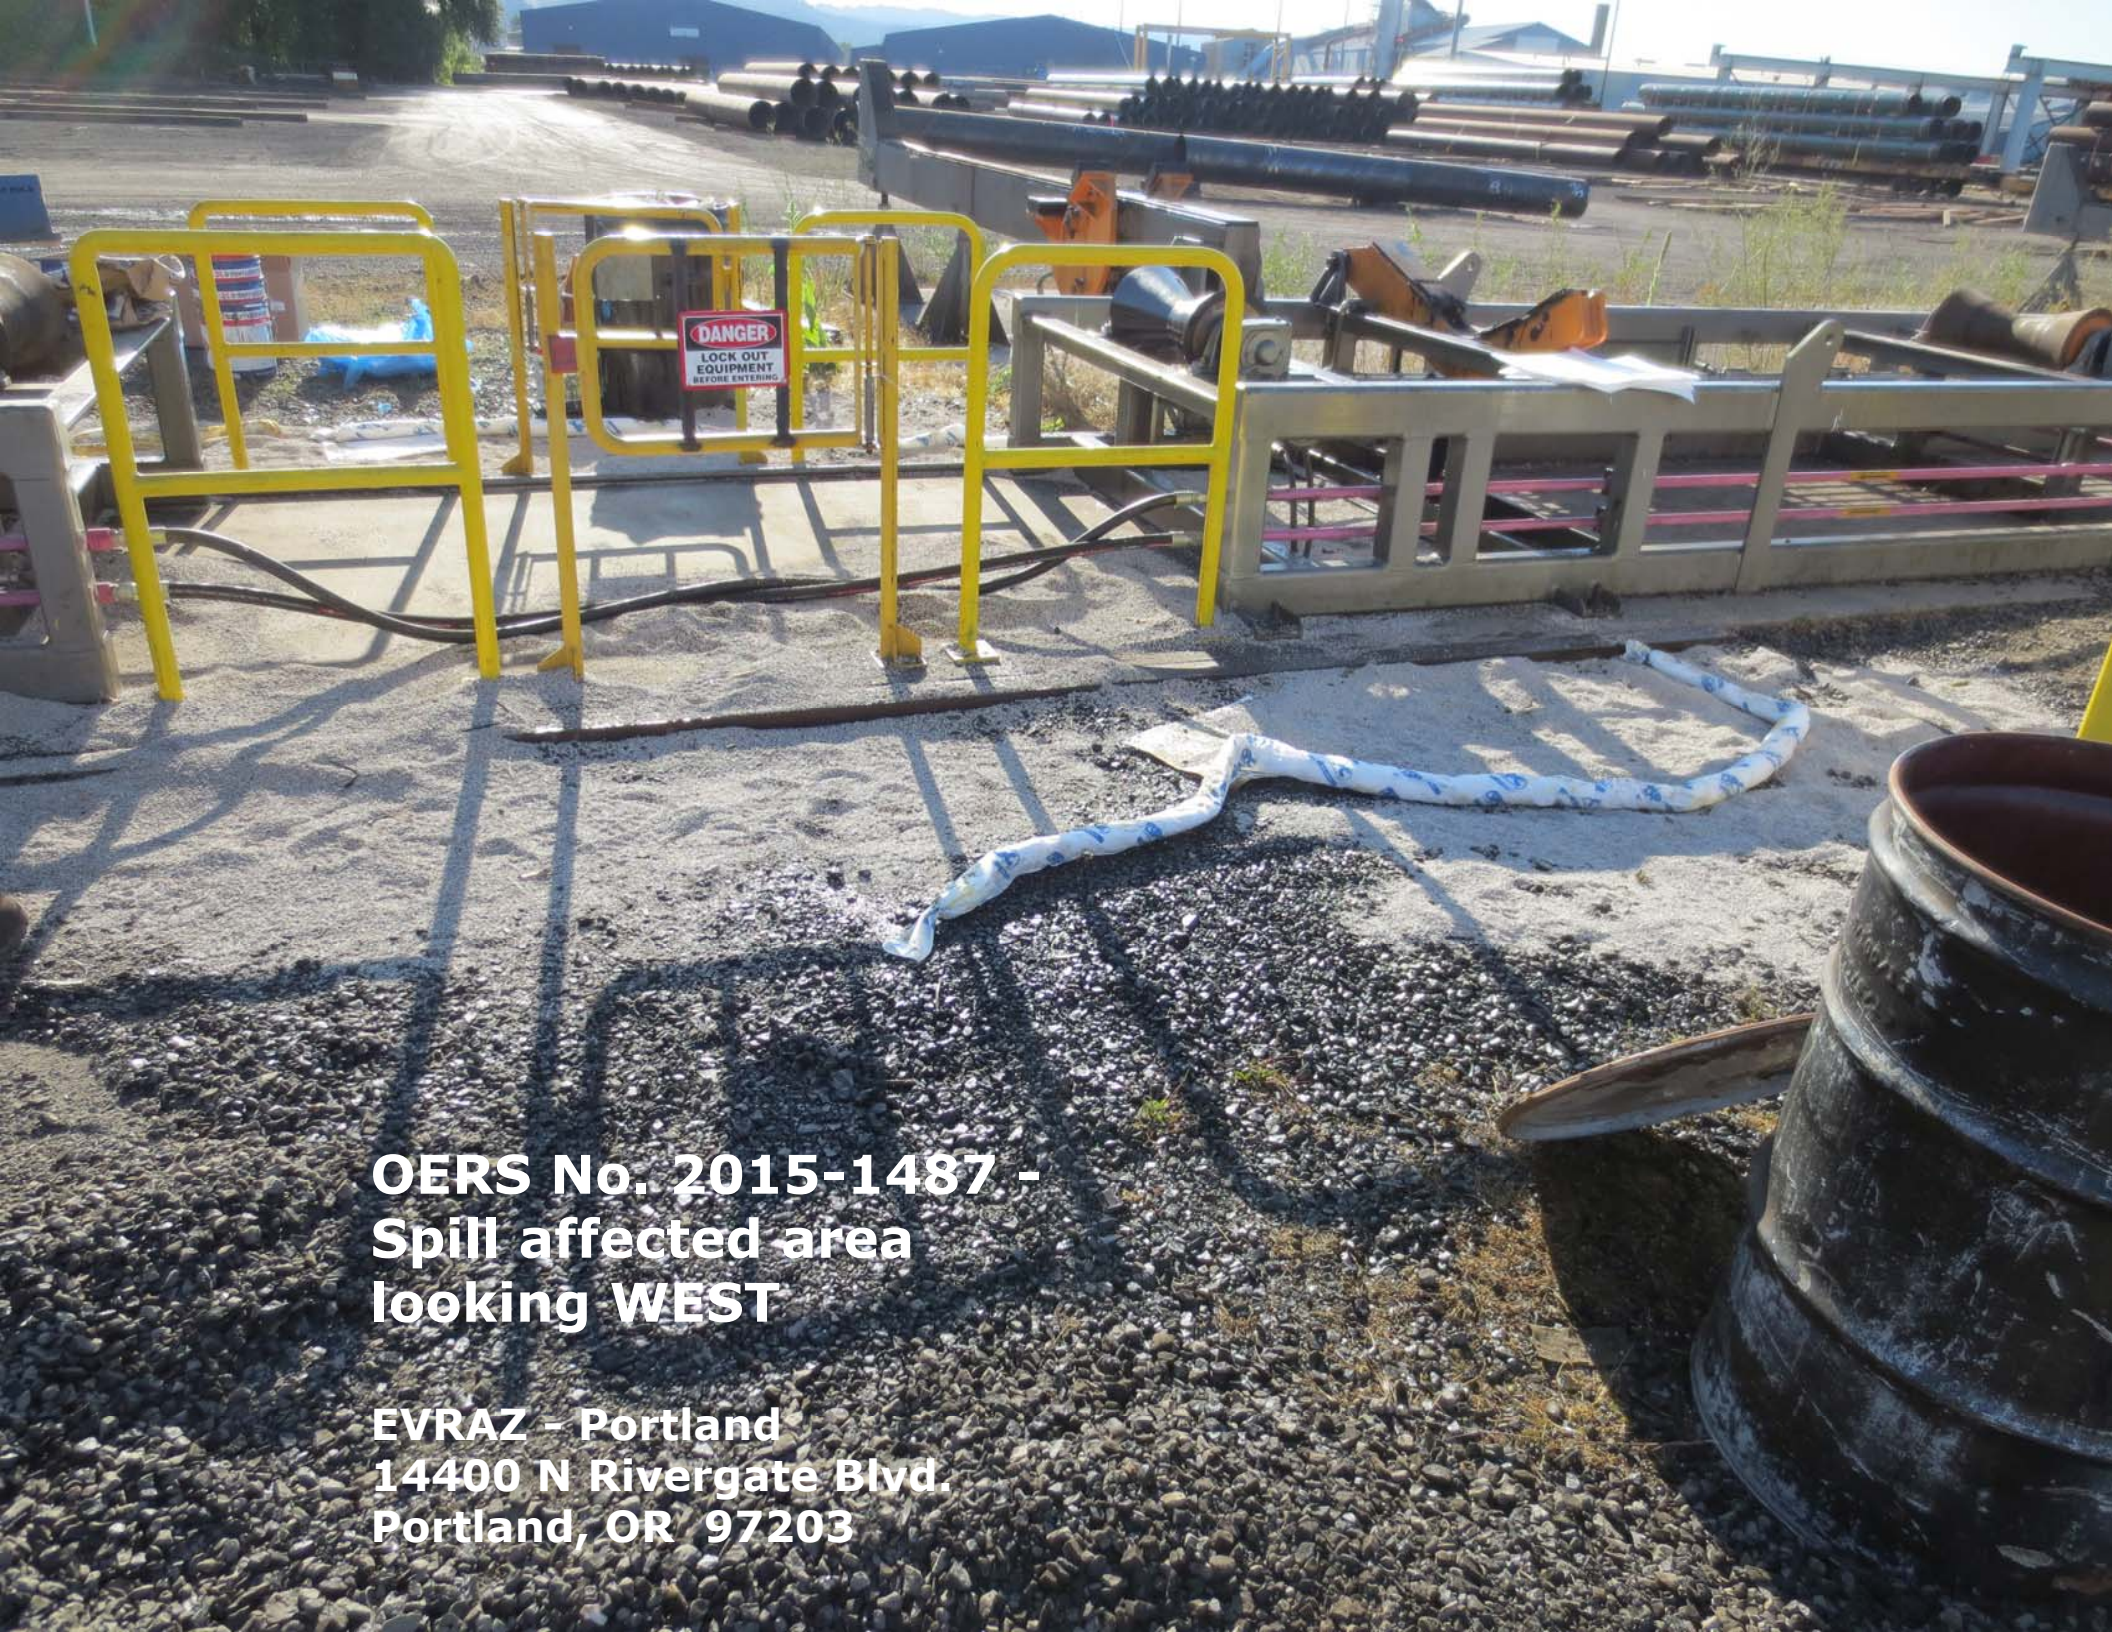
On 7/07/2015, at approximately 6:00 PM, a hydraulic hose on the roll line at the Pipe Mill Double Joiner facility failed. Approximately 150 gallons of Blue Star HL 6890/46 lubricant oil was released to a concrete pad underneath the roll line. Some of the oil was released to the aggregate soils on both the east and west sides of the concrete pad. Absorbents were initially used to contain the released lubricant oil from the ground surface. Spent absorbent material and affected soils (approximately 12 cubic yards) were removed to the extent possible by outside contractor, Terra Hydr. Initial excavation of the affected area took place on 7/7/2015. Subsequent excavation of the affected area was performed on 7/12/2015 after issuance of an EVRAZ internal excavation permit was completed. The weather was sunny and dry. Excavated soils were covered and stored in an on site containment area prior to disposal. The hydraulic line that caused the release was replaced the same day as the spill on 7/7/2015. Select import granular material was placed in the excavated area and compacted. Affected media was disposed of at the Riverbend Landfill on 7/31/2015.

**OERS No. 2015-1487 -
Spill affected area
looking WEST**

Explain: A hydraulic hose failed on a roll line at the Pipe Mill Double Joiner. The hose line has been repaired thus eliminating the potential for a future release from this line

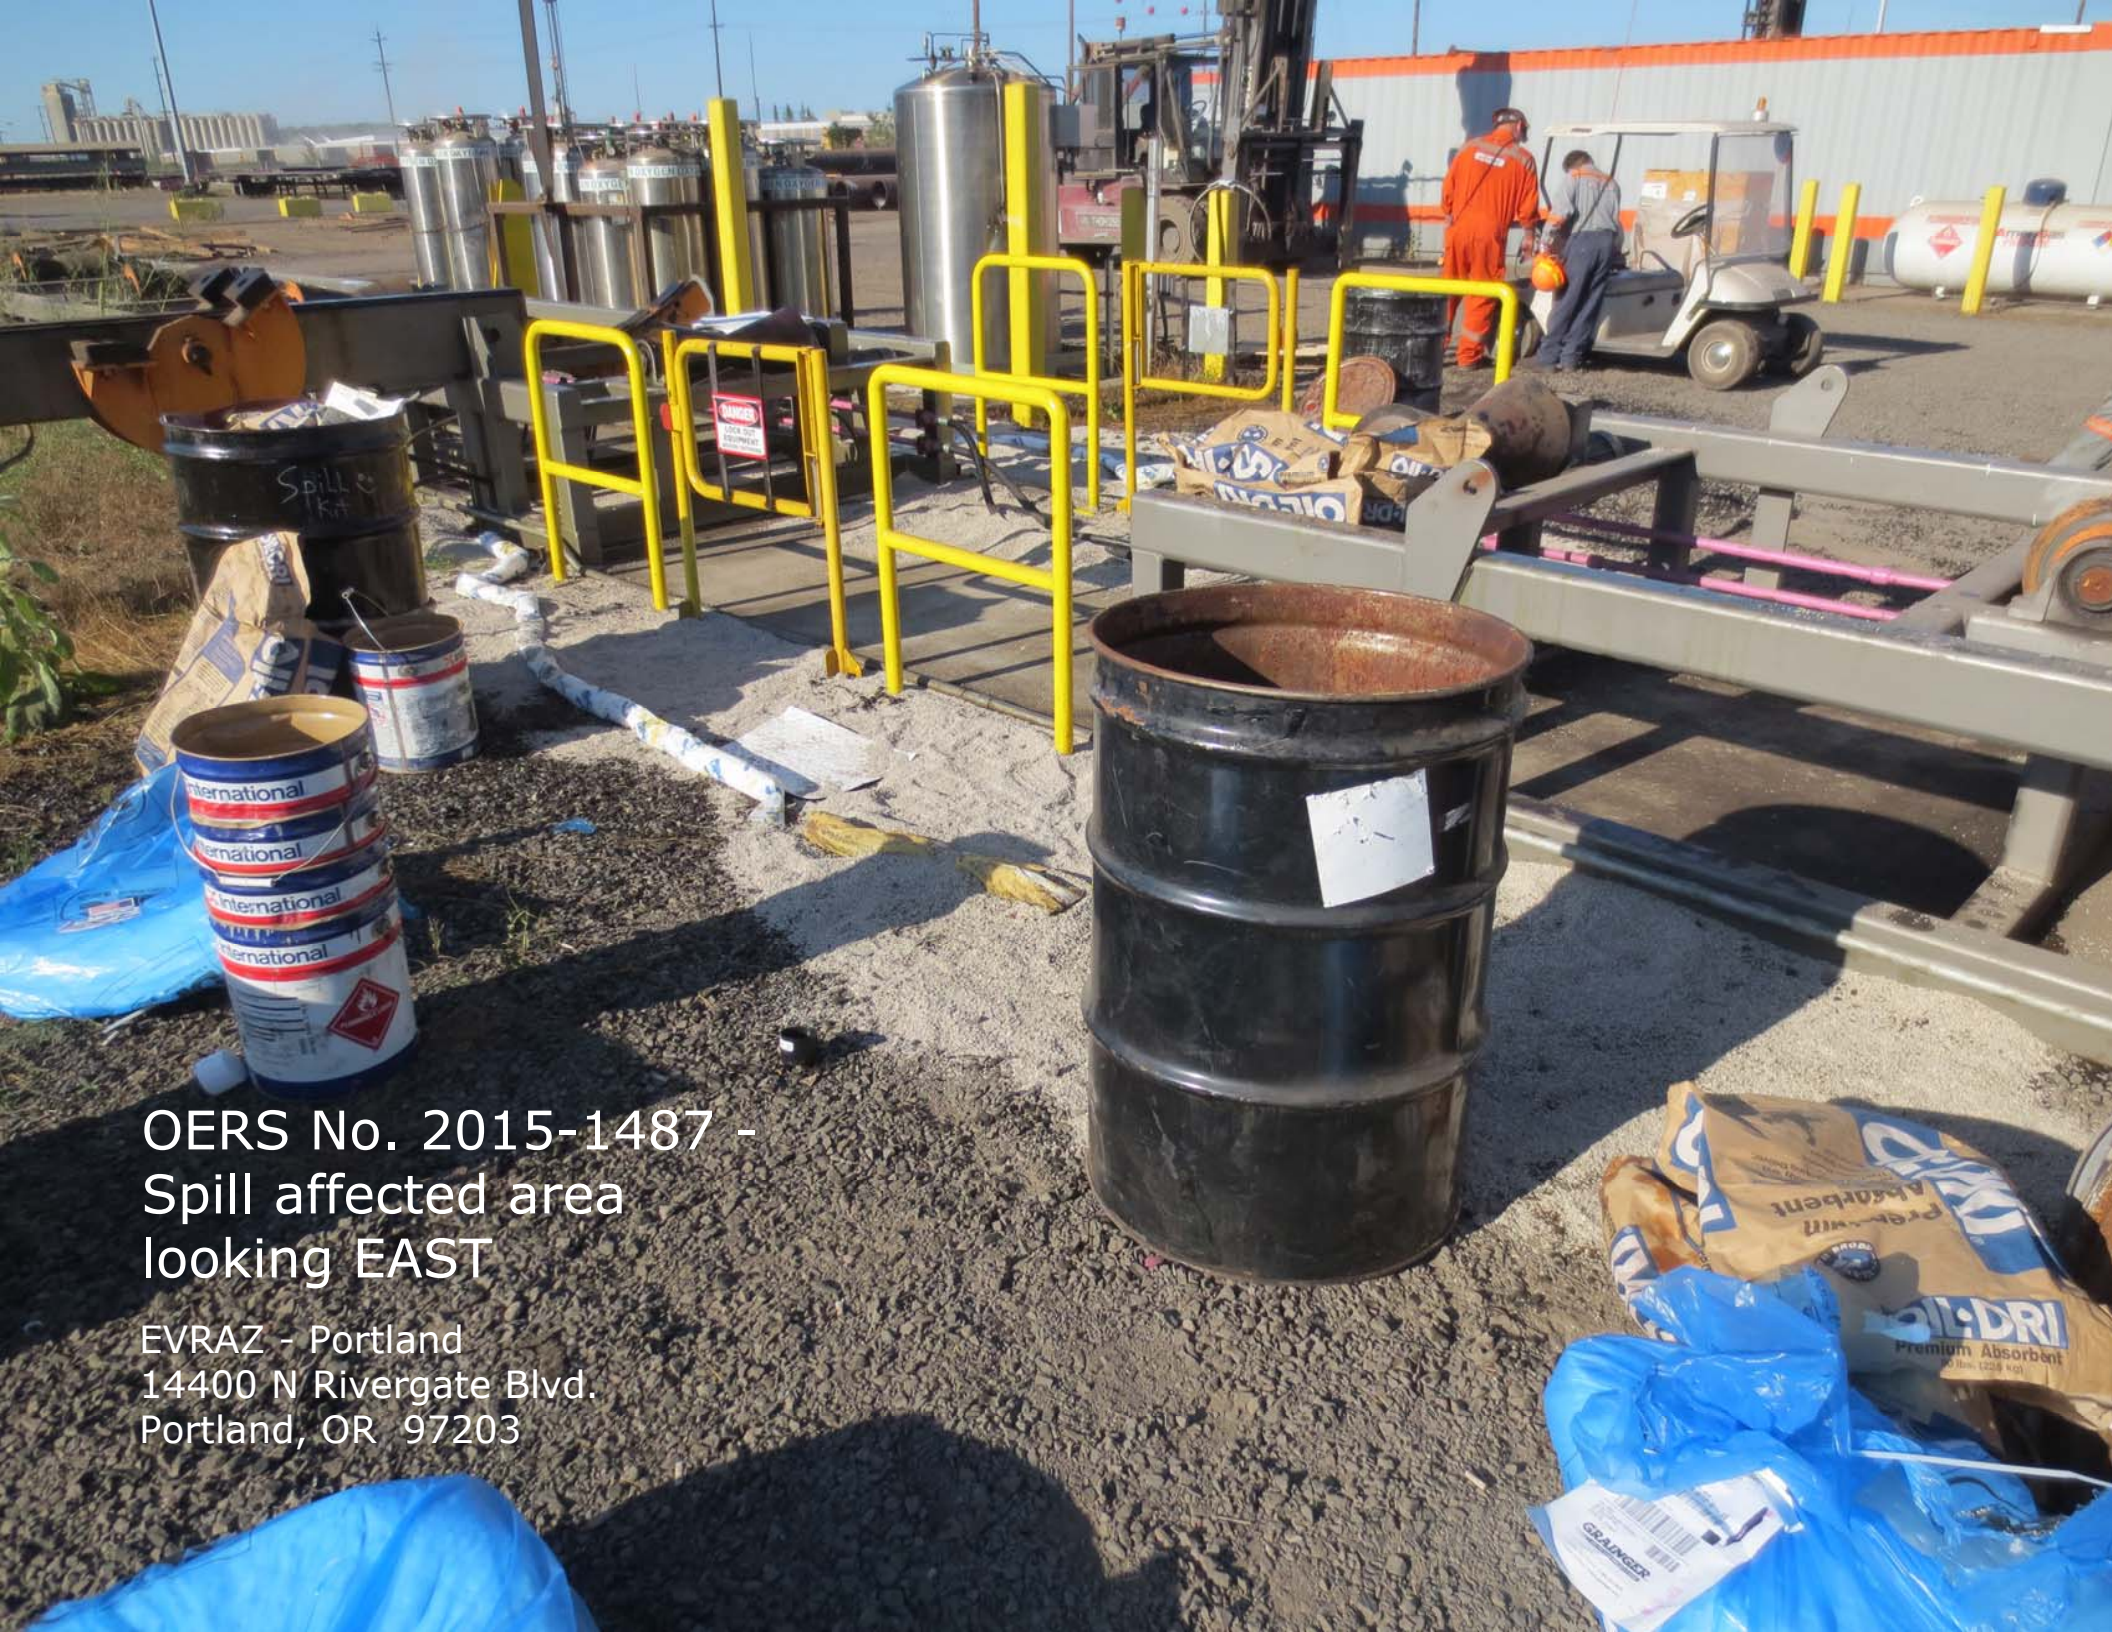
OERS No. 2015-1487 -
Spill affected area
looking EAST

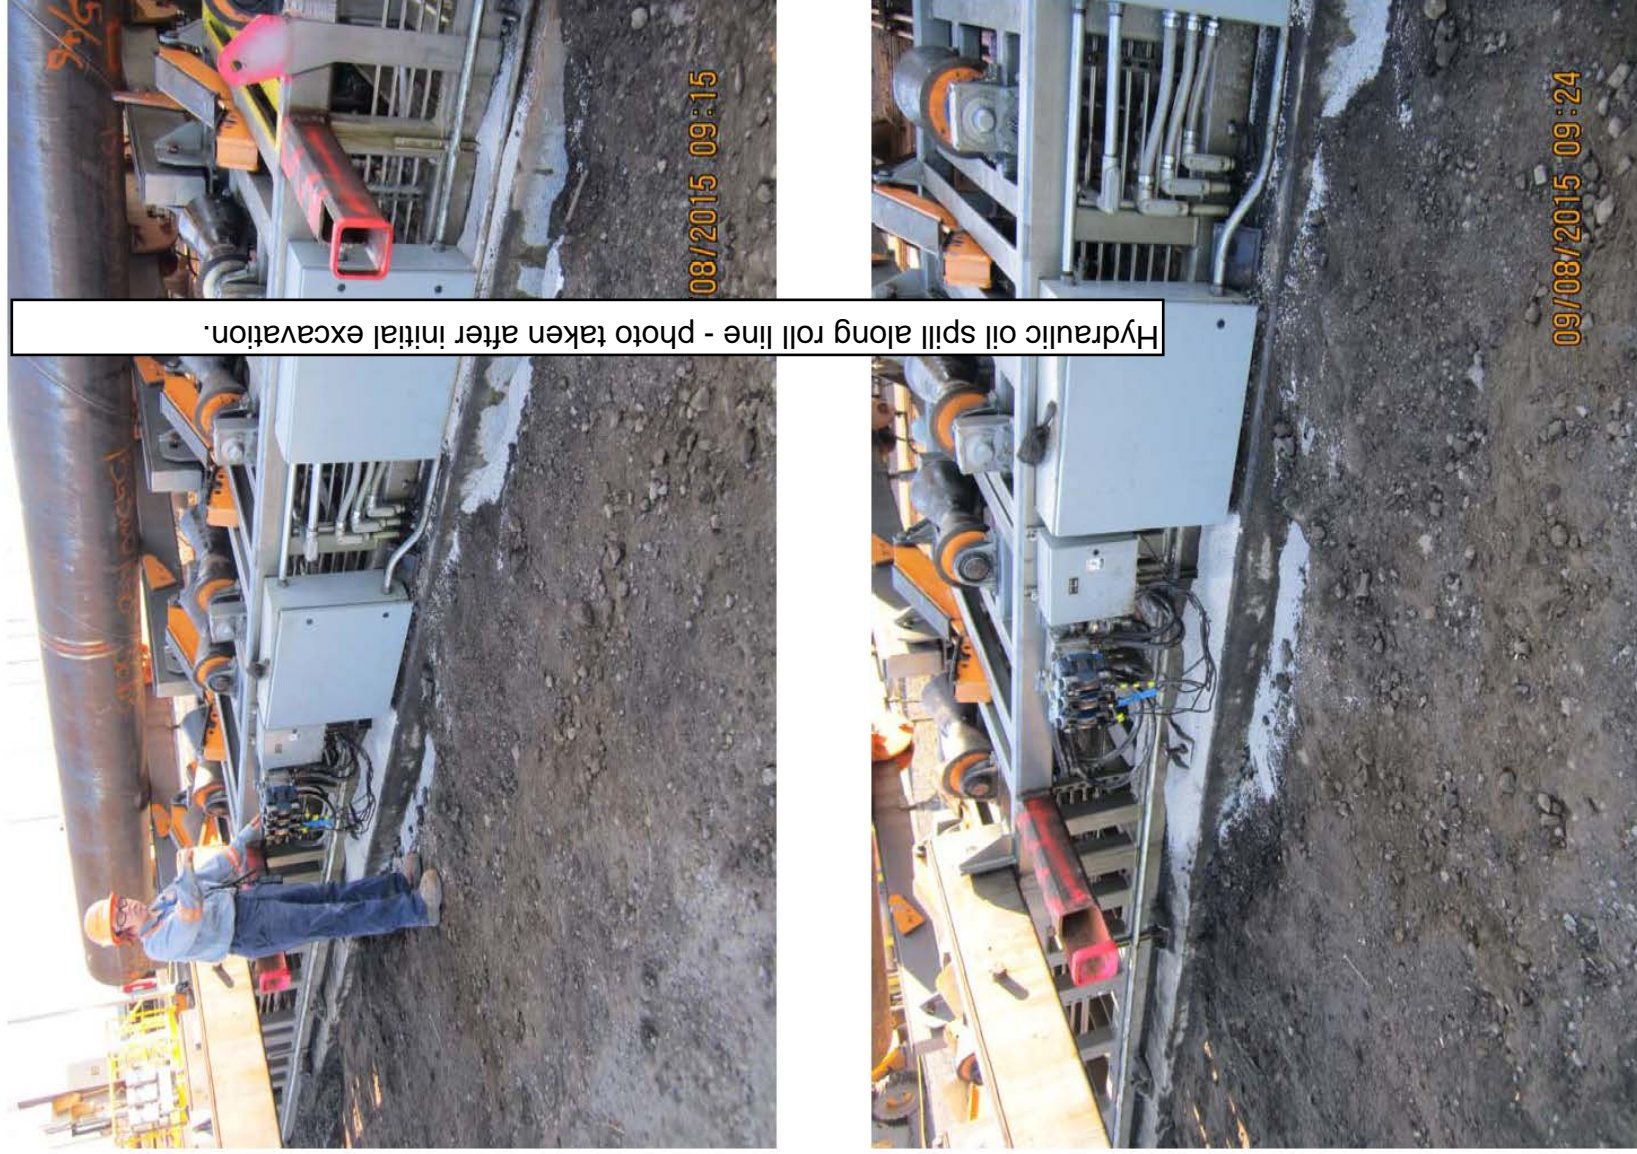
On 9/7/2015, at approximately 11:20 PM an improperly loaded pipe on a roll line conveyer system at the Double Joiner facility, "hopped" off the roll line and fell on a hydraulic system, damaging the hydraulic line. The damaged hydraulic line caused a release of approximately 100 gallons of Blue Star HL 6890/46 lubricant oil to a concrete pad underneath the roll line and aggregate soils on the west side of the concrete pad. Absorbents were initially used to contain the released lubricant oil from the ground surface. Spent absorbent material and affected soils (approximately 2 cubic yards) were removed to the extent possible by outside contractor, Terra Hydr. Initial excavation of the affected area took place on 9/8/2015. Subsequent excavation of the affected area was performed on 9/12/2015 after issuance of an EVRAZ internal excavation permit was completed. The weather was sunny and dry. Excavated soils were covered and stored in an on-site containment area prior to disposal. The hydraulic line that caused the release was replaced on 7/8/2015. Select import granular material was placed in the excavated area and compacted. Affected media was disposed of at the Riverbend Landfill on 10/02/2015.

Explain: An improperly loaded large steel pipe "hopped" off a roll line conveyance system and fell on an adjacent hydraulic system and caused a release of hydraulic fluid. Steel tubing guard surrounding the hydraulic system has been installed to prevent a similar occurrence.

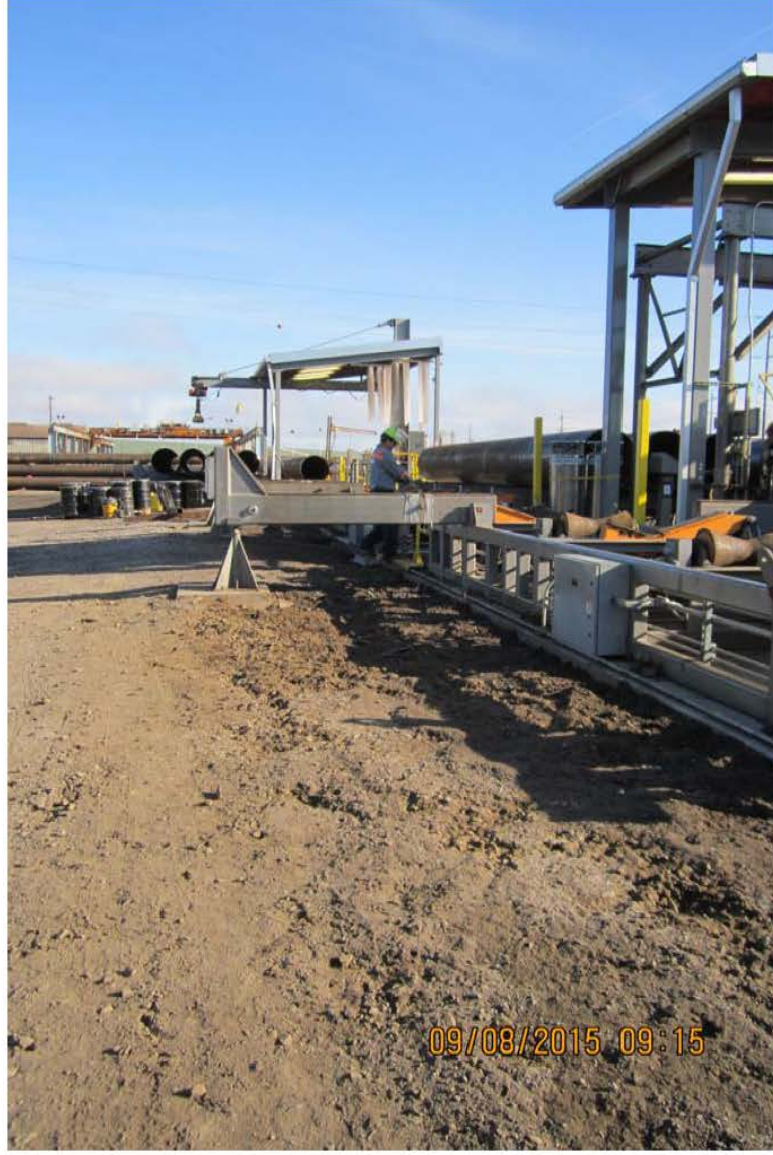
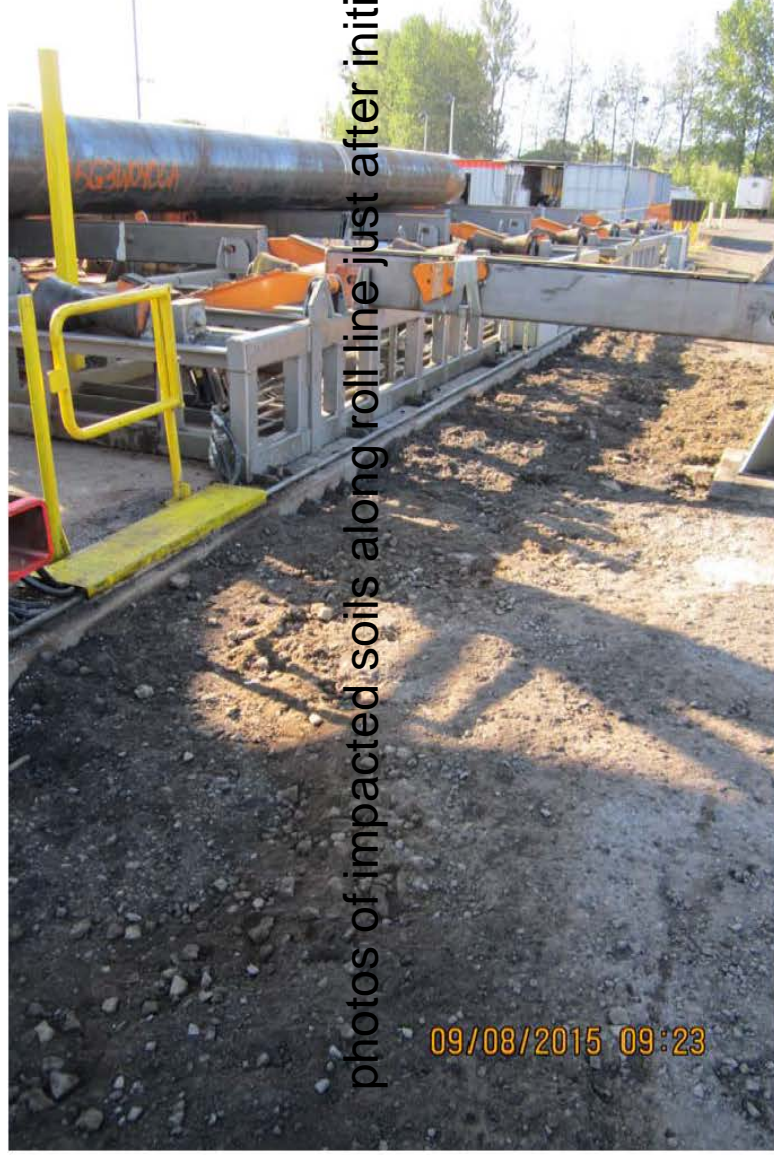
OERS 2015-2056 - hydraulic oil spill September 7, 2015

photos of impacted soils along roll line just after initial excavation

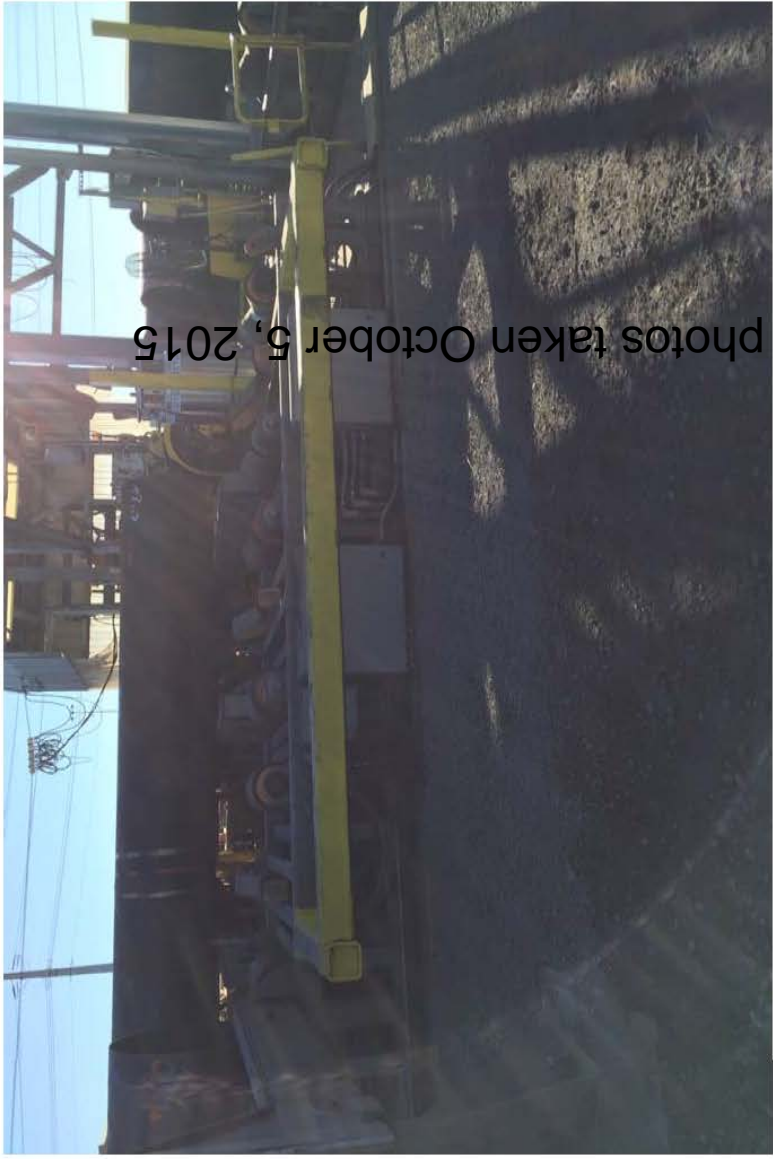
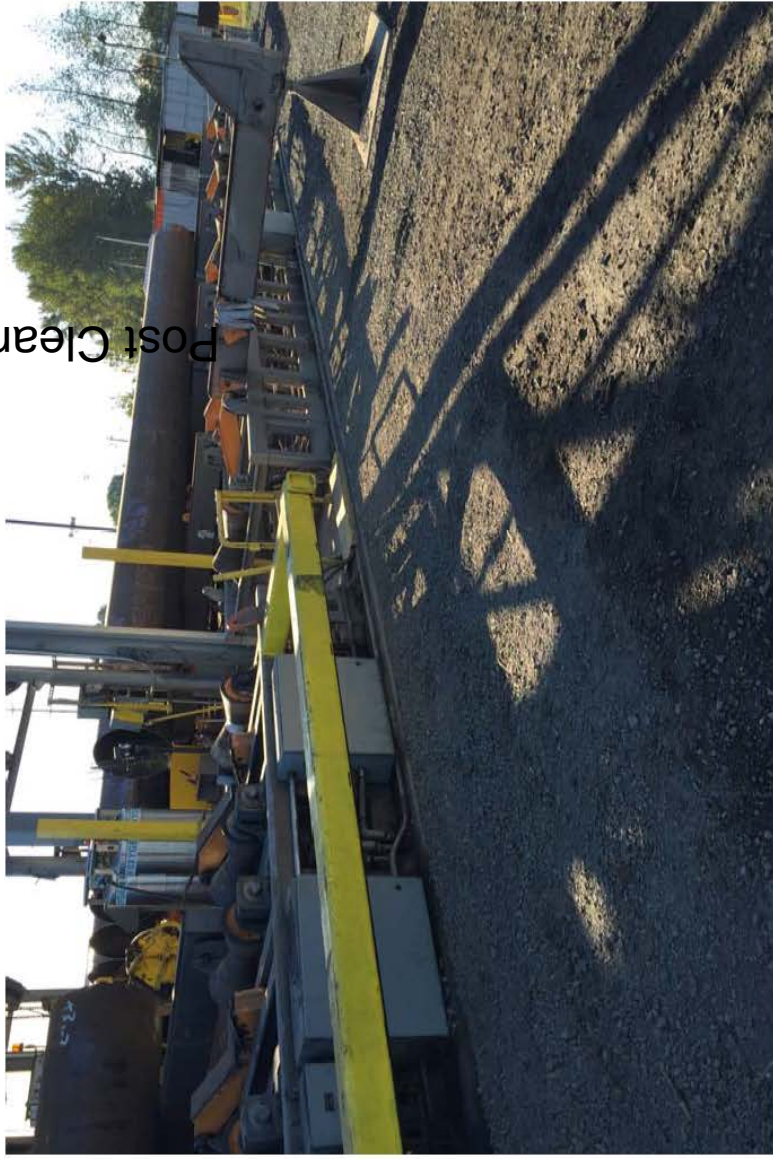
EVRAZ Portland - Double Joiner - Post clean-up
OERS 2015-2056 - hydraulic oil spill - Sept. 7, 2015

Post Clean-up photos taken October 5, 2015

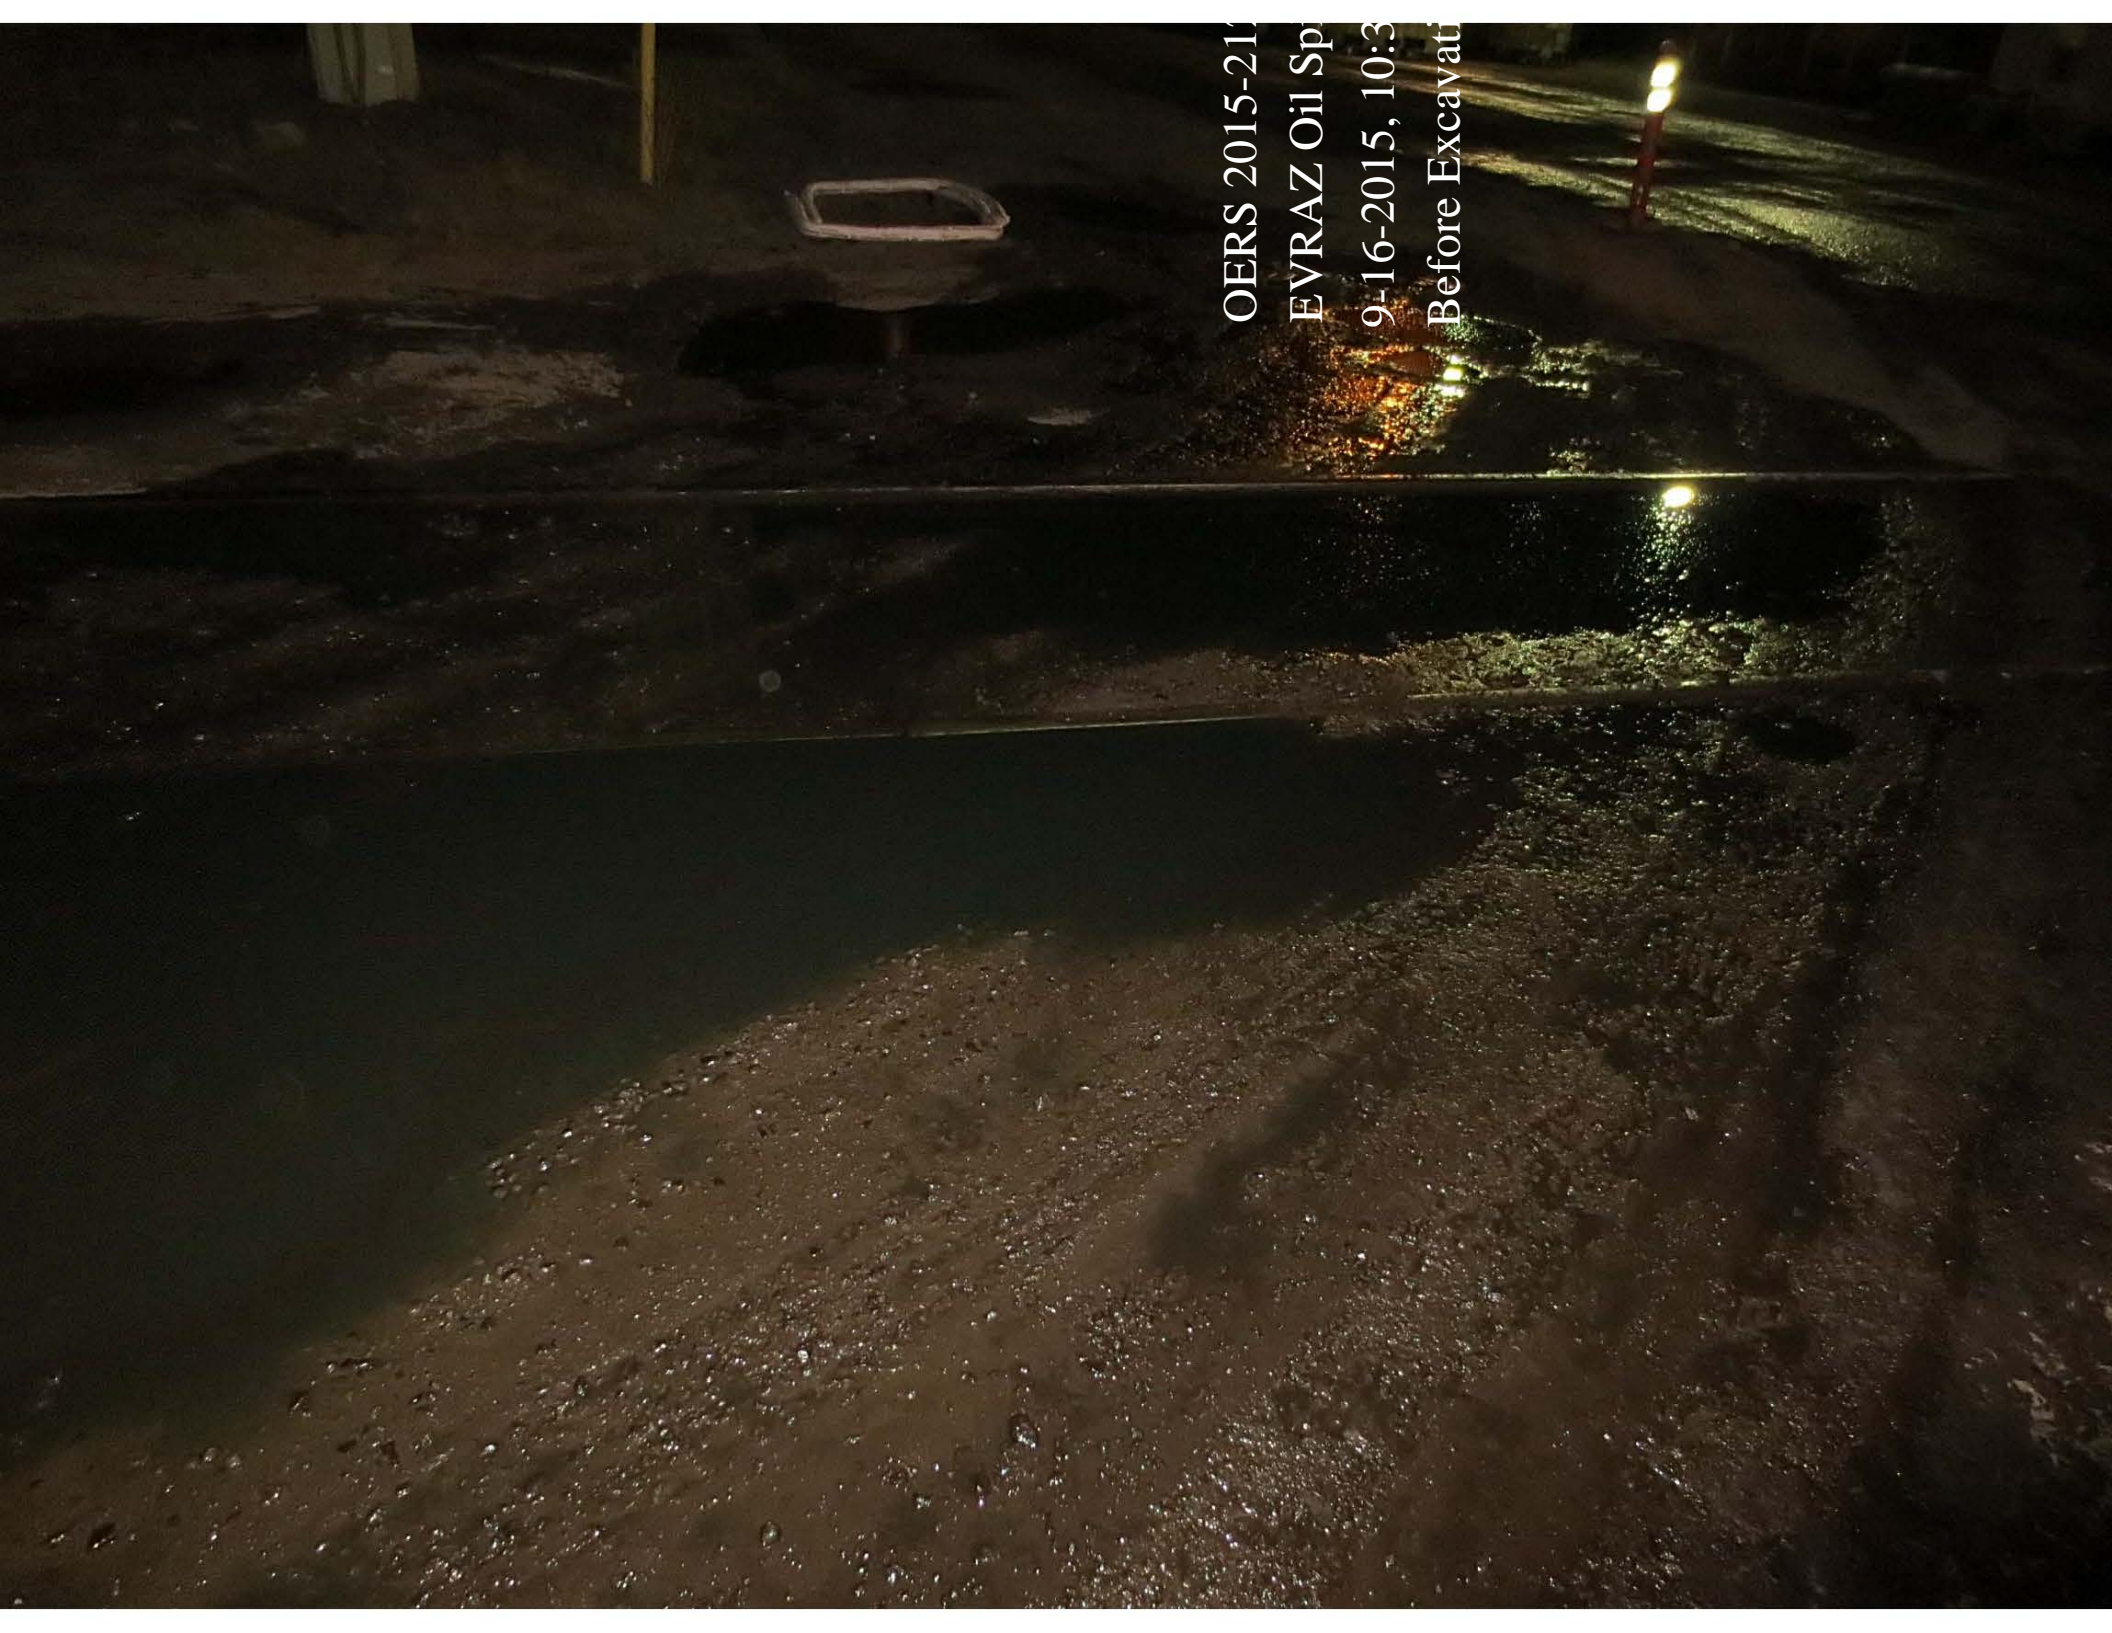
On 9/16/2015 at approximately 7:30PM an employee was using a forklift to transport a tote of 6810/46 hydraulic oil. The forklift encountered a pot hole in the road which caused the tote to slide off the forks and tip over. The cap on the tote popped off and a release of approximately 75-80 gallons of oil to highly compacted soils occurred. A nearby storm drain catch basin was protected with a spill mat and oil absorbent socks. Oil absorbent materials (clay and pads) were initially used to contain the released oil from the soil surfaces. Spent absorbent material and affected soils (approximately 5 cubic yards) were excavated to the extent possible by outside contractor, Terra Hydr at approximately 10:30 PM on 9/16/2015. No release of oil to the storm drain system occurred, however the catch basin was cleaned out as a precaution. The weather at the time of the spill was dry however slight sprinkle occurred later in the evening during excavation. Excavated soil media was temporarily covered and stored at a designated on-site containment area prior to disposal. A Two point composite confirmation sample of the excavated area was taken on 9-17-2015 after the visibly impacted soils were excavated to the extent possible. The excavated area was restored using granular rock on 9-18-2015. Affected media was disposed of at the Riverbend Landfill on 10/2/2015.

OERS 2015-217
EVRAZ Oil Sp
9-16-2015, 10:3
Before Excavati

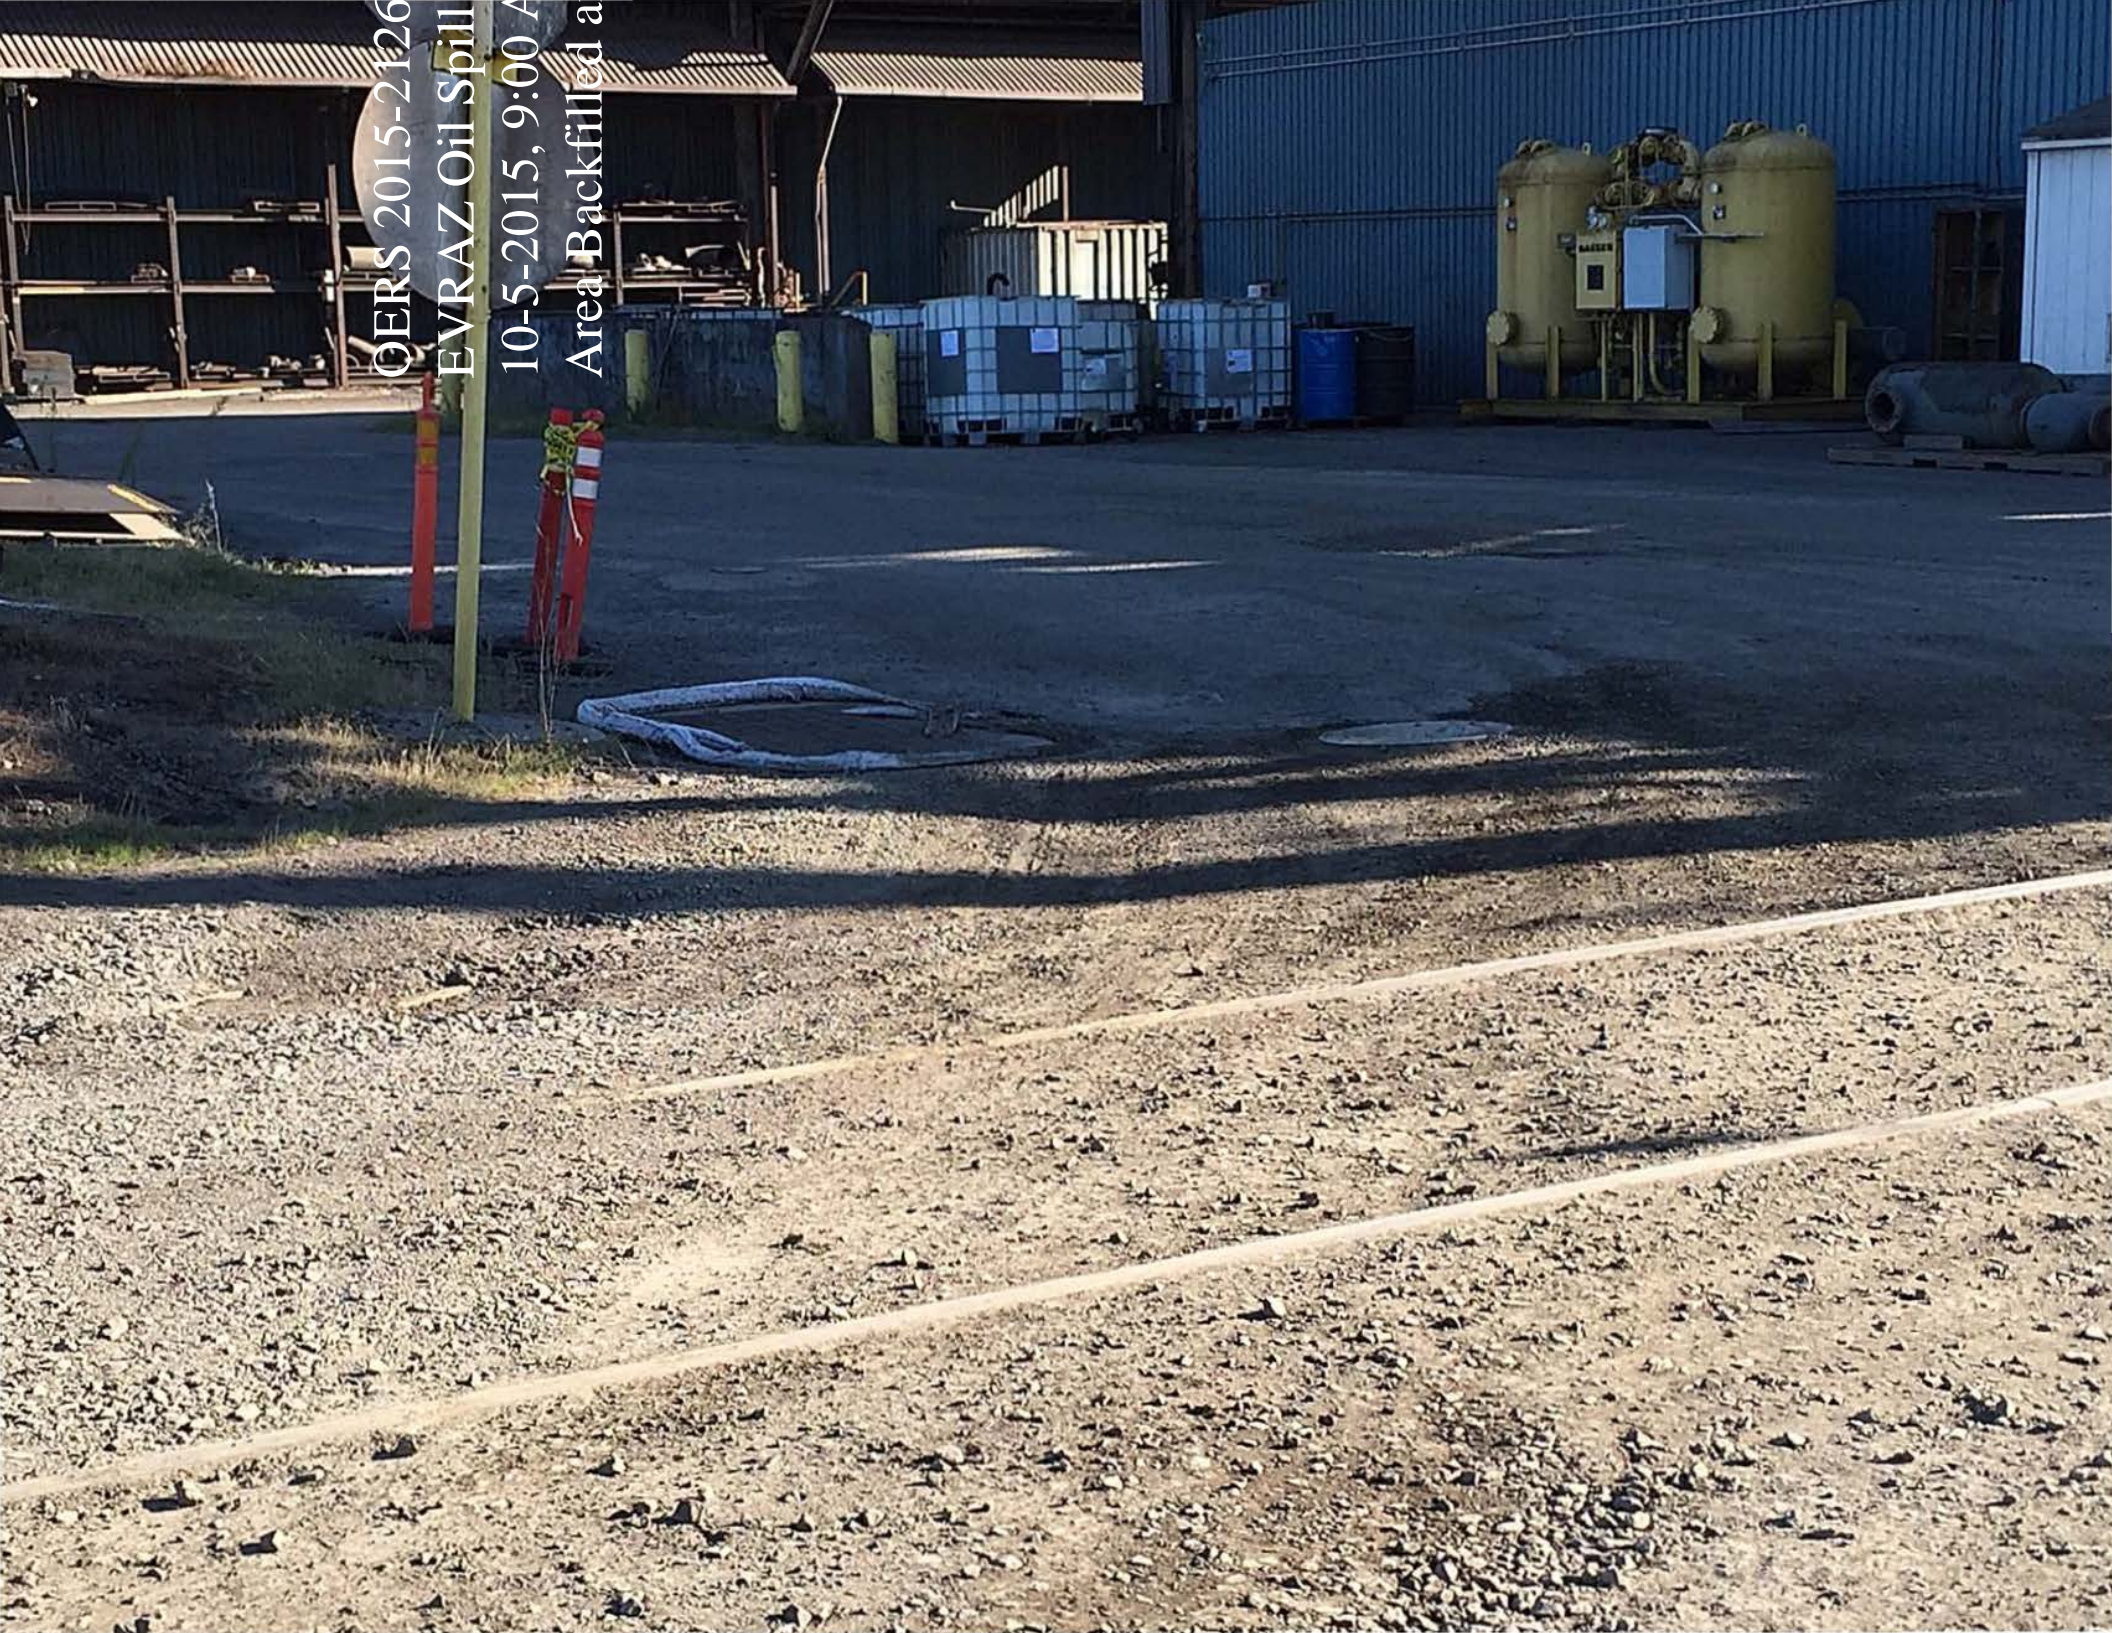
QERS 2015-2126
EVRAZ Oil Spill
10-5-2015, 9:00 A
Area Backfilled a
